## Service Experience Gas Carriers – Hull Structures

Morten A. Lerø [morten.lero@dnv.com](mailto:morten.lero@dnv.com)  
Øyvind Wilhelmsen [Oyvind.Wilhelmsen@dnv.com](mailto:Oyvind.Wilhelmsen@dnv.com)  
Det Norske Veritas AS, Høvik, Norway

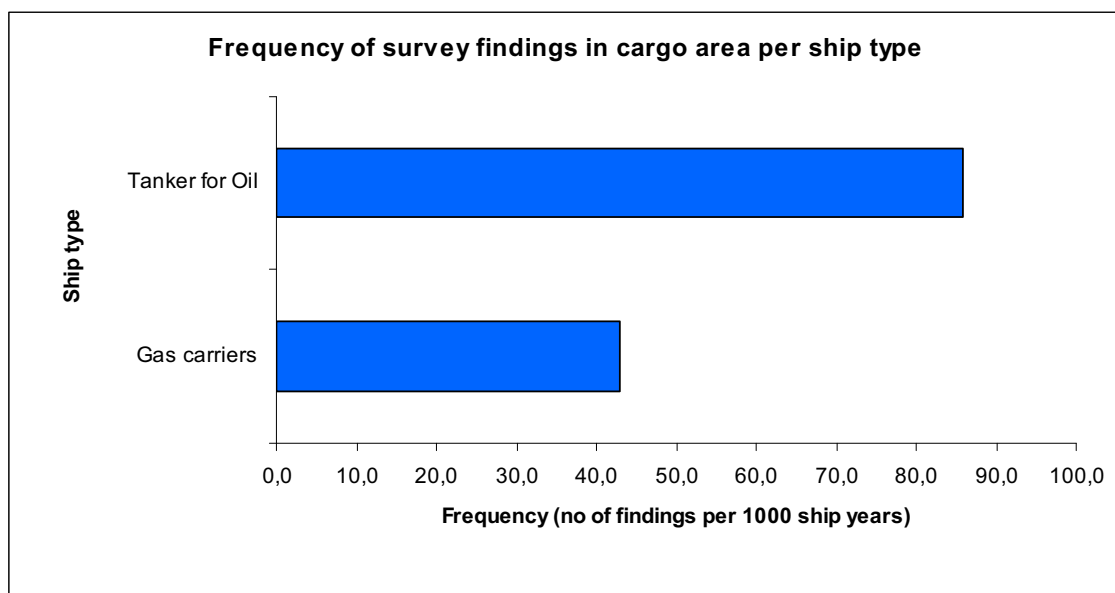
Fig 6 Frequency of survey findings in cargo area

The frequency of findings for gas carriers is less than for oil tankers.

Corrosion and cracks are the most frequently reported damages for both oil tankers and gas carriers. The frequency of cracks is approximately at the same level for oil tankers and gas carriers. Corrosion is occurring more frequently in oil tankers than in gas carriers. The reported number of cracks is at the same level in LPG vessels of tank type A and C. For the LNG vessels the age distribution of the vessel types included is so different that a comparison is not relevant.

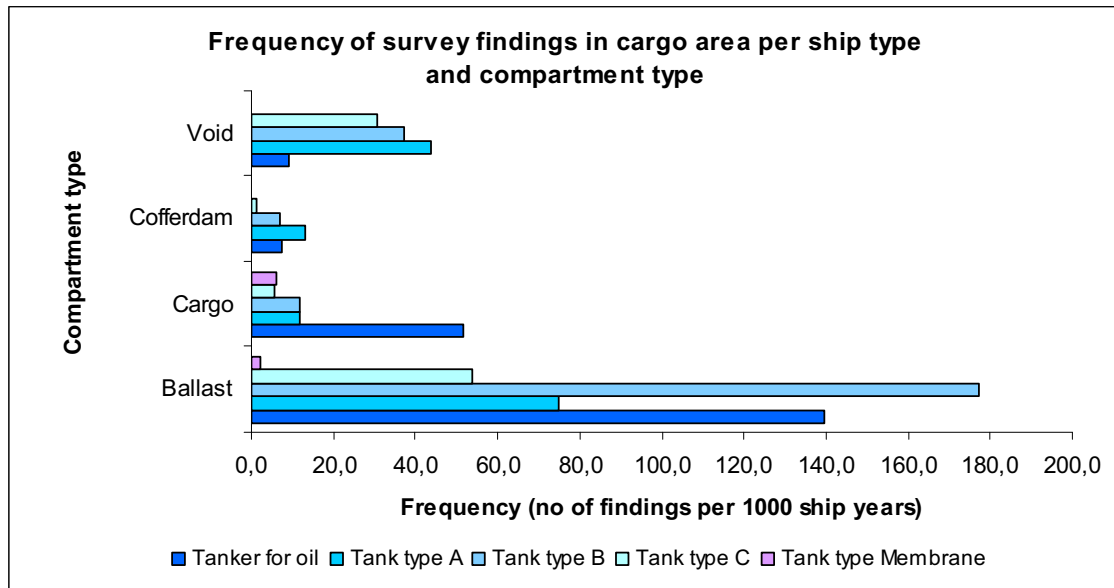
Fig 7 Frequency of findings in cargo area per shiptype and compartment type

The reported damages in ballast tanks are more frequent in oil tankers than in gas carriers. The damage frequency for oil tankers is almost twice that of gas carriers. In gas carriers the pattern of the findings in the ballast tanks show same trend as that of the oil tankers;

The compartments with the most frequent findings are top wing tanks, hopper tanks and side tanks, where as the number of findings in the double bottom tanks is significantly lower.

For cargo tanks the frequency of findings is low for gas carriers, only a fraction of that of oil tankers.

As many of the gas carriers in the study are vessels with independent cargo tanks, the frequency of findings in voids are more significant than that of oil tankers.

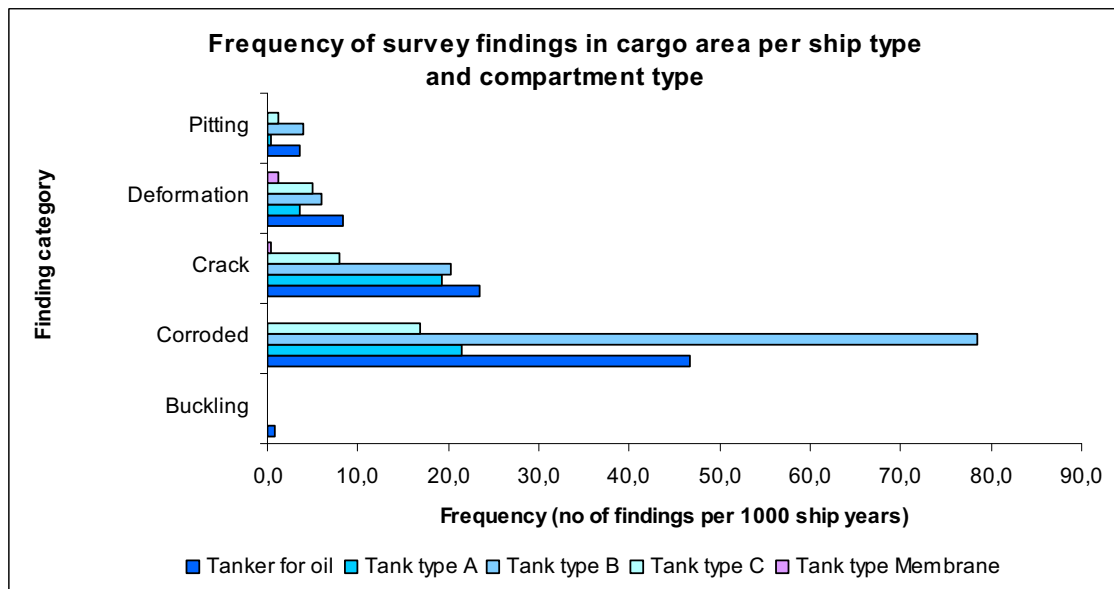
Fig 8 Frequency of findings in cargo area per ship type and damage category

Based on the data assessed, it appears that for some gas carriers (tank type A) cracks are as normal findings as corrosion. For tankers the number of findings related to corrosion is more than twice that of cracks. This trend is the same for most gas carrier types. The finding frequency related to corrosion for the B-tank type vessels appears high. It should be noted however that a significant contribution comes from vessels more than 30 years old. With the relatively smaller number of vessels analysed, the impact on the statistics from a few vessels is significant, compared to similar effects on the group of tankers, A-tank vessels and C-tank vessels, where the data base is larger.

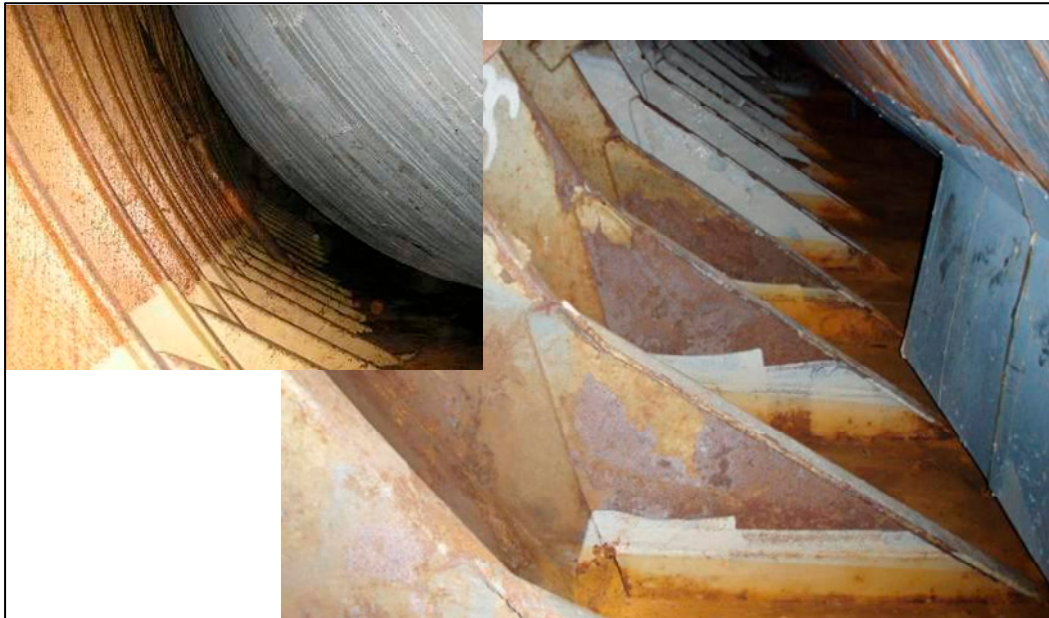
As for the A-tank design, the connection between side frames and innerbottom is considered critical. Cracks are found in these connections.

Fig 12 Connection between side frame and inner bottom.

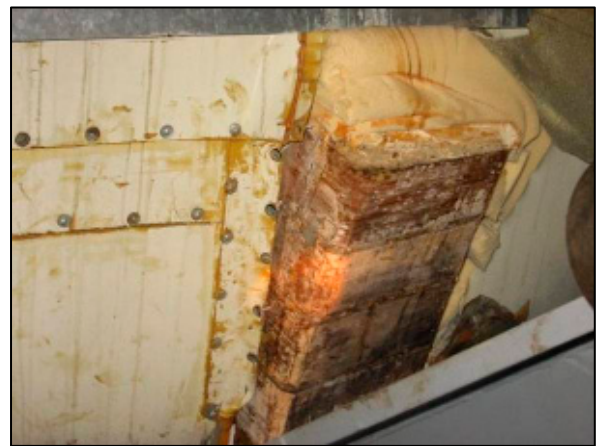
Lack of moisture control in the hold space has also caused problems with the isolating wood between cargo tank and cargo tank support. In loaded/cold condition ice may accumulate on the supports. For some designs using non-impregnated wood in the support saddle, the wood may swell and get distorted.

Fig 14 Damaged wood

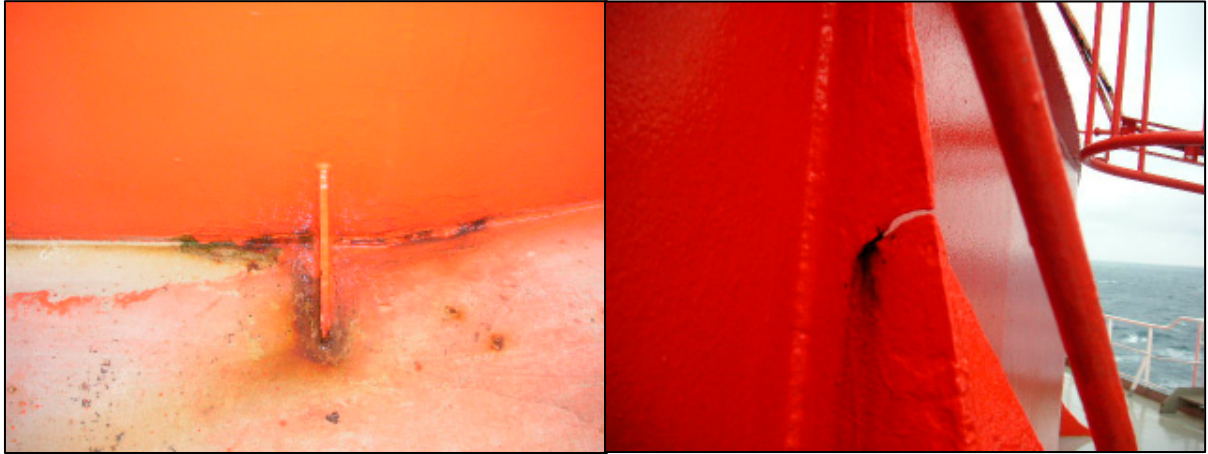
For an LNG carrier of spherical type a re-occurring finding is cracking of the connection between cargo tank cover and deck. The crack along the deck is loosening up the tank dome connection. If these cracks penetrate to deck it could become a longitudinal strength issue.

Fig 15 Cracks in deck connection in way of cargo tank covers
